Wednesday, August 14, 2019

Level 1, Premium Reserve Analysis

Ventana HOA Northern & Bandera Pueblo, CO 81005

FINAL REPORT

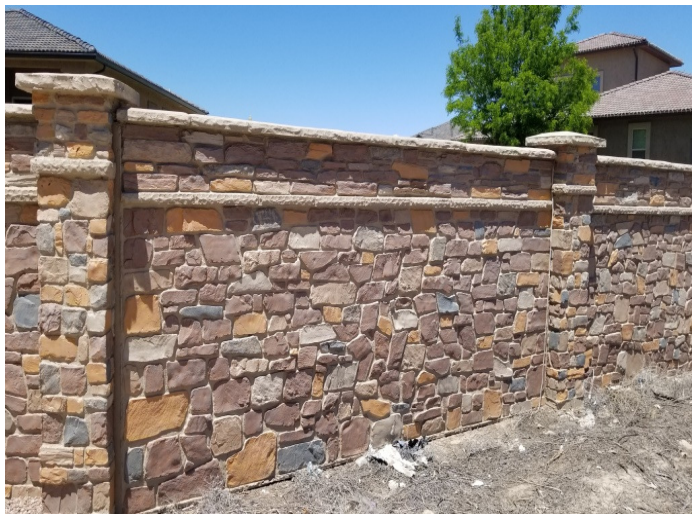
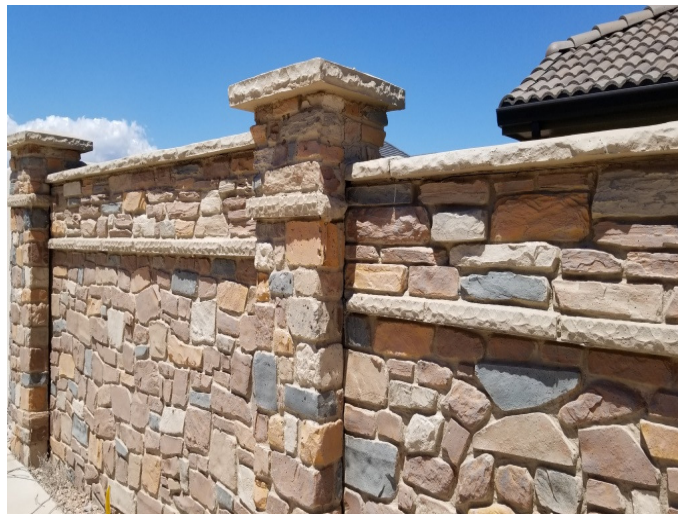
Comp #: 208 Concrete "Stone" Wall - Stain

Wall should be stained every 10 - 12 years to maintain appearance.

Life Expectancy: **10** **Remaining Life:** **5**

\$14.50/LF; Estimate to restain/paint

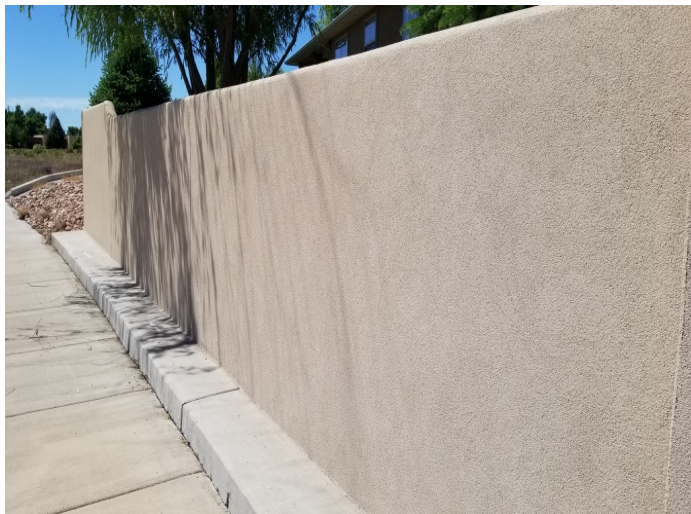
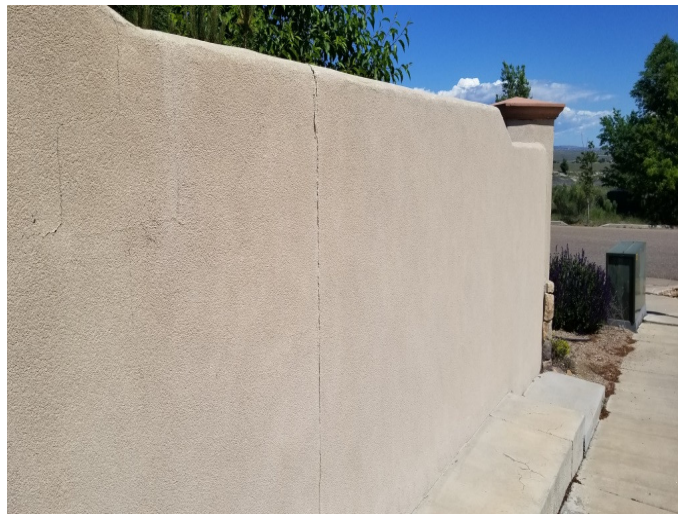
Comp #: 208 Stucco Wall - Repaint

- These surfaces should be painted approximately every 10 - 12 years to maintain appearance and prevent damage to stucco surface.

Life Expectancy: **12** Remaining Life: **0**

\$0.85/GSF; Estimate to repaint

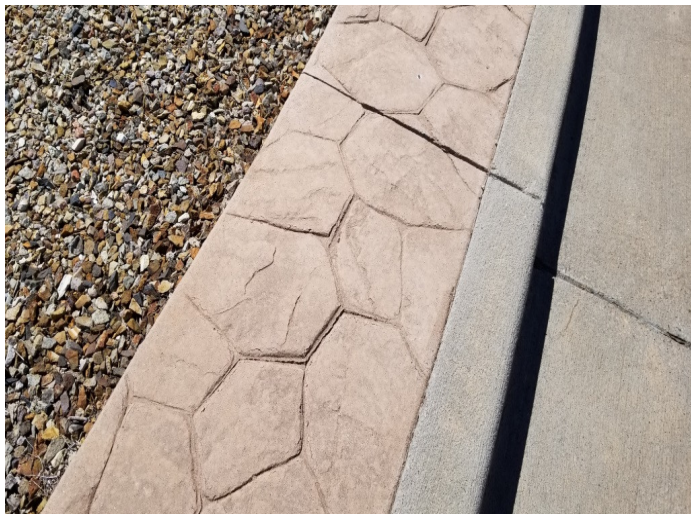
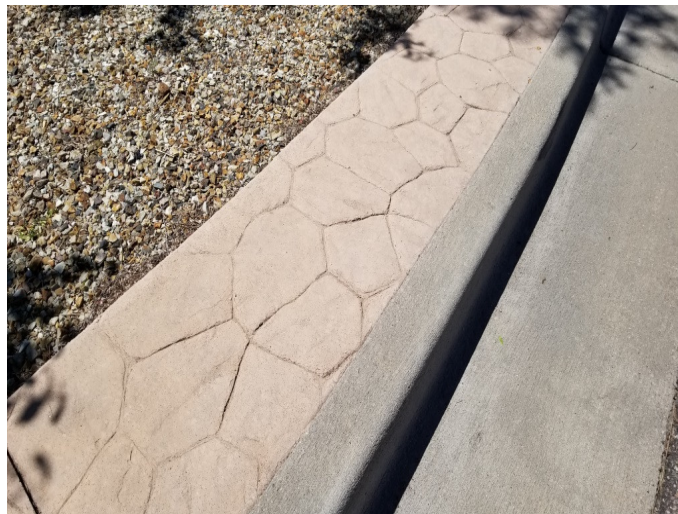
Comp #: 405 Stamped Concrete - Repair/Replace

- While periodic repairs are a possibility, with repairs, it is difficult to match the design of the stamp and the color.
- Therefore, we recommend replacement of the driveway every 20 - 30 years.
- We suggest coordinating this to occur at the same time as other concrete work for best cost estimate.

\$16/GSF; Estimate to replace

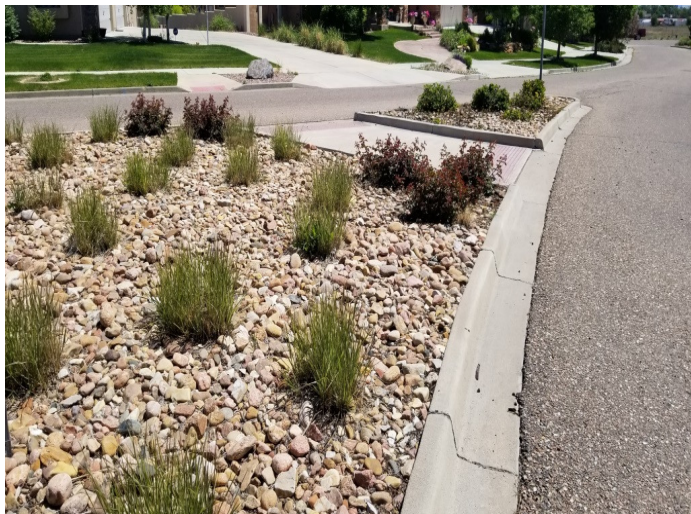
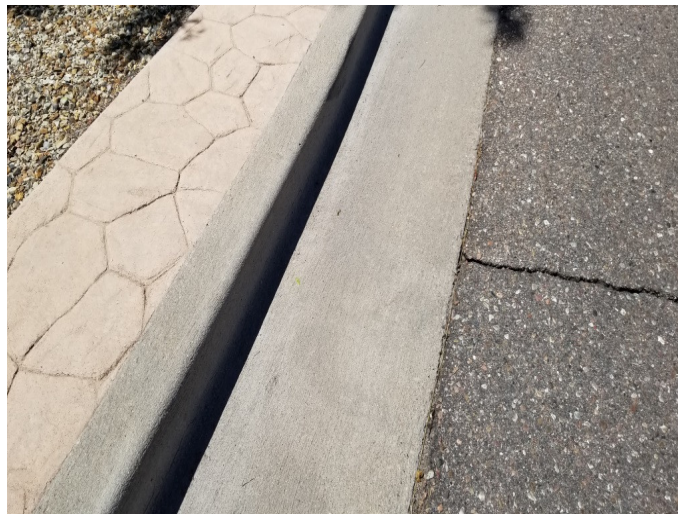
Comp #: 407 Curb and Gutters - Partial Replace

- Since it is unlikely all surfaces will need to be replaced at the same time, we suggest establishing a Reserve fund to repair a percentage (approximately 600 GSF) of the area every 6 years.
- For best cost results, we suggest coordinating future repairs with other concrete work

Estimate to repair 15% of area every 6 years

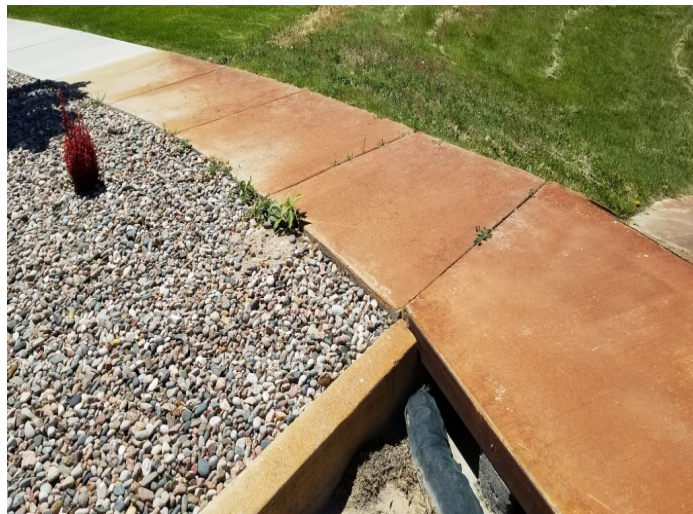
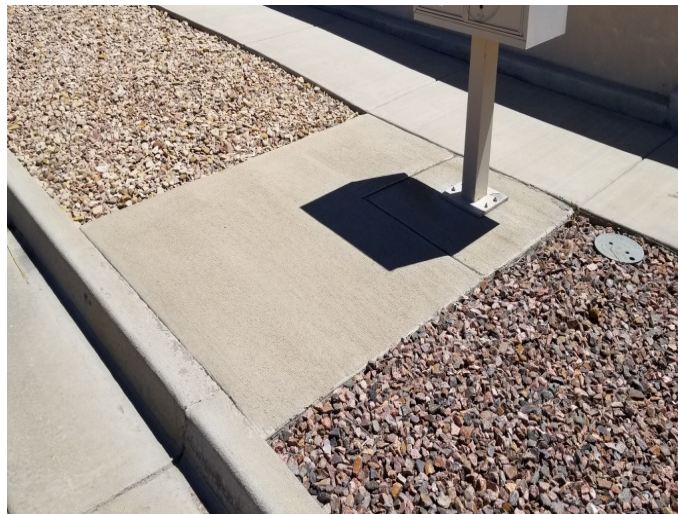
Comp #: 601 Concrete Flatwork - Partial Replace

- It is unlikely all areas will fail and need to be replaced at the same time.
- Therefore, we set an allowance of 10% of the total area measured (350 GSF) to be repaired every 6 years.
- As the property continues to age, it is likely that the percentage of repairs will need to be adjusted in future Reserve Study updates.

Allowance to repair 5% of area every 5 years

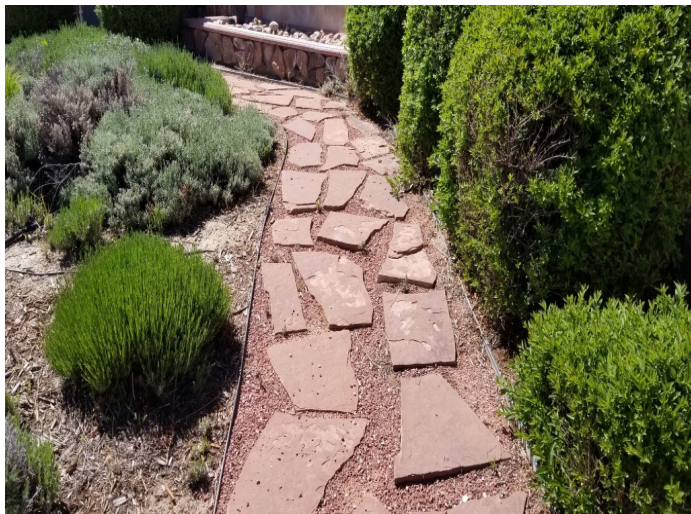
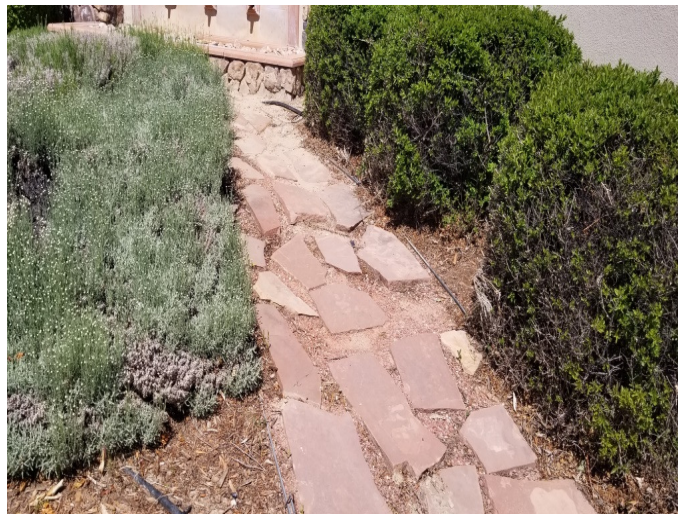
Comp #: 603 Flagstone Pathways - Major Repairs

- No unusual conditions observed.
- Due to small area, include funding along with "Groundcover - Replenish" line item (see component #1801)

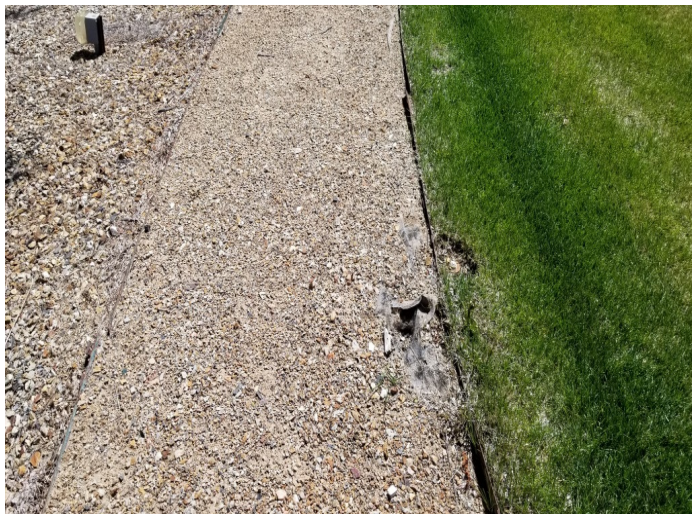
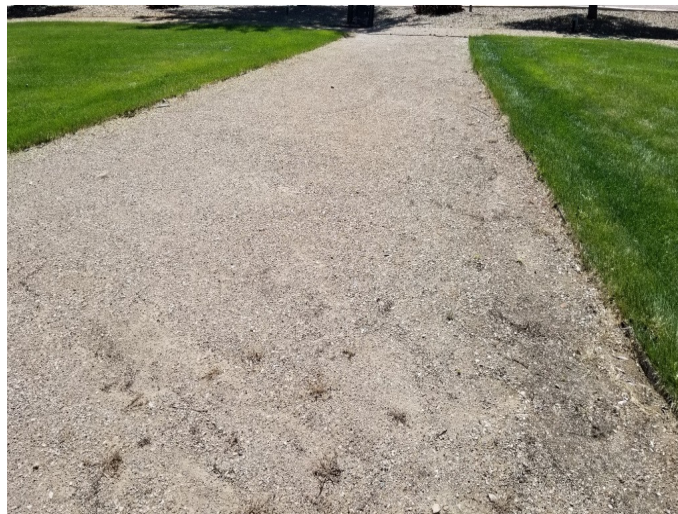
Comp #: 625 Breeze/Crushed Granite - Replenish

- Due to the location of the paths, these paths will be subject to frequent wash outs and continual high maintenance requirements
- We recommend addressing these paths every 6 - 7 years with new material and cutting back the overgrown areas.
- Estimated cost also includes repairs and replacement of the metal edging. Current conditions are dangerous with sharp, rusted edges.

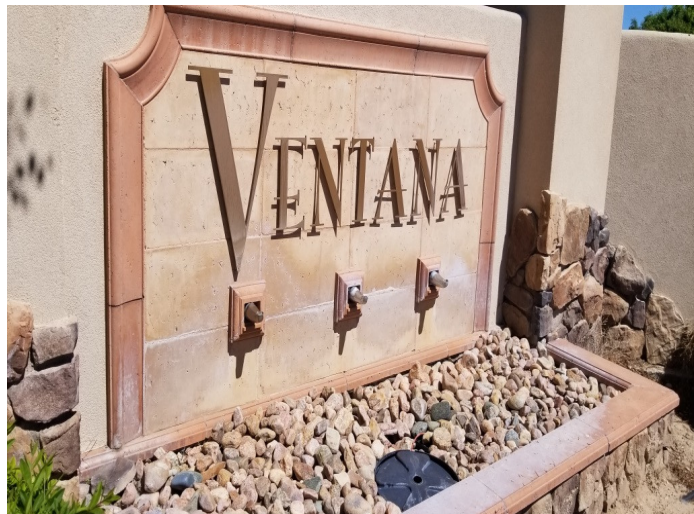
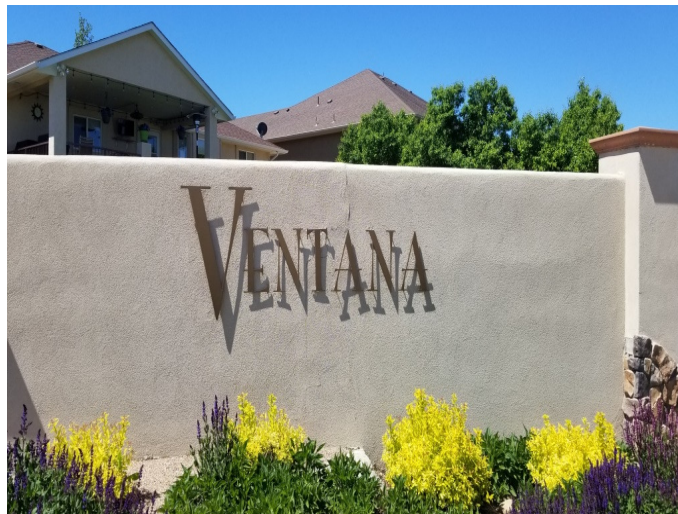
Comp #: 801 Monument - Refurbish

- While the materials used should have an indefinite life expectancy, we recommend planning on renovating monument every 20 - 25 years to maintain current trends and an appropriate appearance.
- Remaining life is based on observed conditions and approximately age of all monuments.

Allowance for general repairs

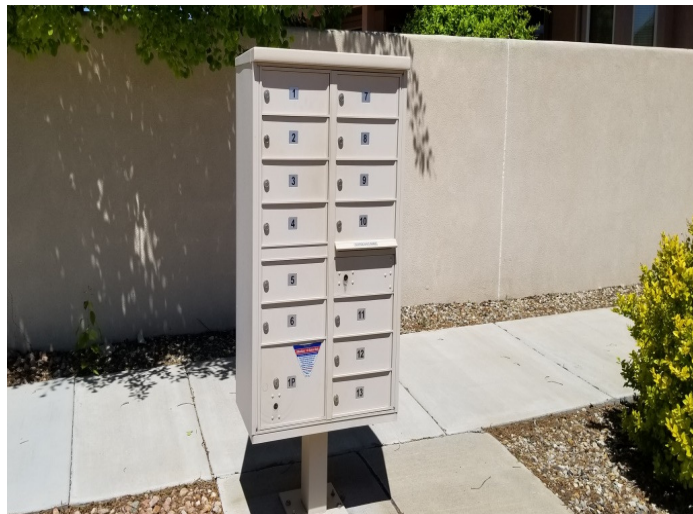
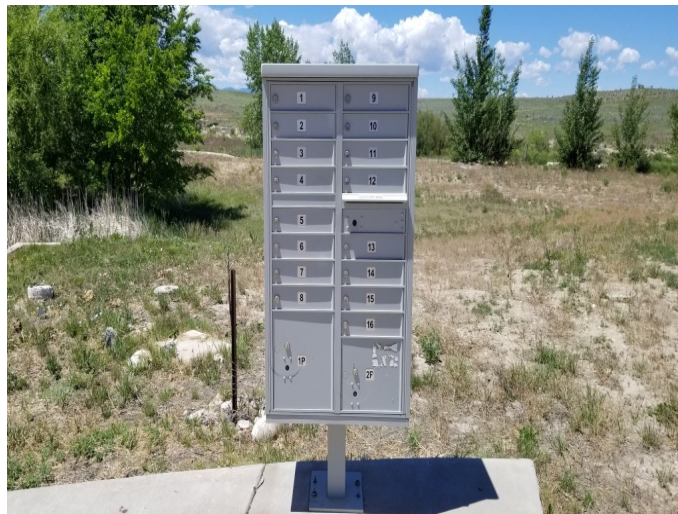
Comp #: 803 Mailboxes - Replace

- This line item is for the original mailboxes that were installed when construction of the community began.
- Per new Postal regulations effective 2012, "all customers are responsible for repairs and replacement of keys, locks, or the boxes/cluster units themselves".
- Based on our experience, these boxes will have a life expectancy of 15 - 20 years due to location and quality.
- Remaining life is based on age and observed condition.

\$1900/CBU; Estimate to replace

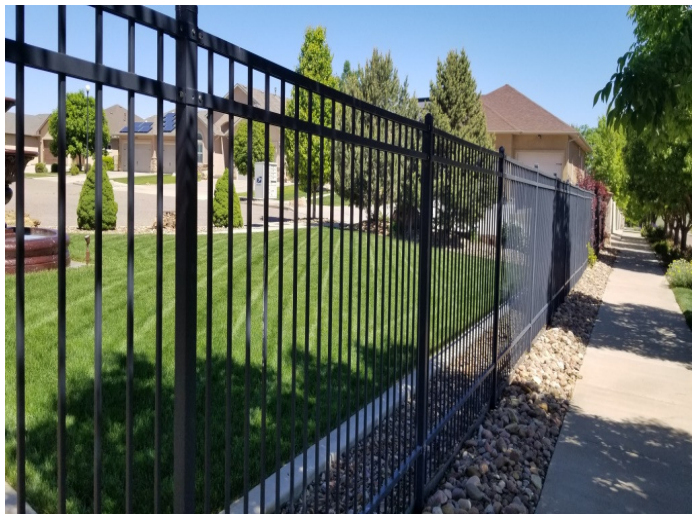
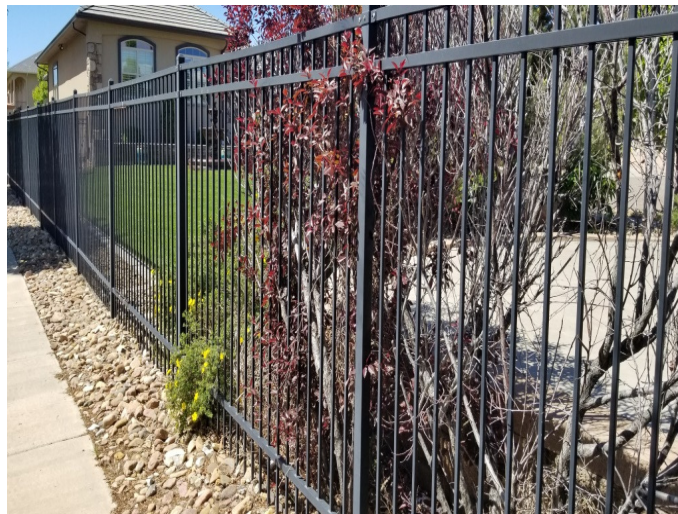
Comp #: 1002 Aluminum Fencing - Replace

- The average life expectancy for metal fences ranges between 25 - 35 years, depending on maintenance schedules and exposure to elements.
- The remaining life is based on age of fence and observed conditions.

\$60/LF; Estimate to replace

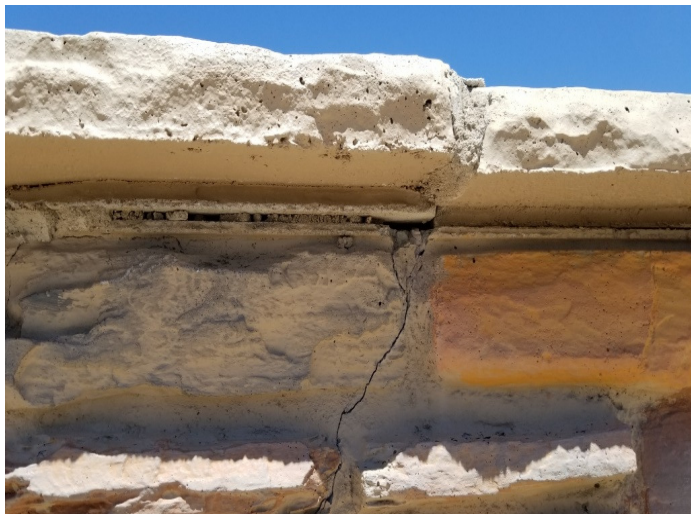
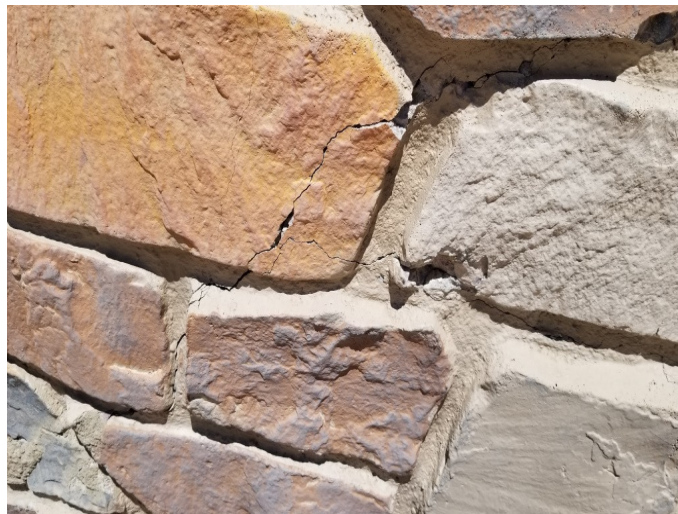
Comp #: 1005 Concrete "Stone" Wall - Inspect/Major Repairs

- There were approximately (9) 17' sections that has significant cracks that will require repairs to prevent further deterioration of the concrete materials.
- This type of fence is a prefabricated concrete molded fence that is manufactured off site, then brought to the community and installed in place. Once installed, the wall is then stained to give it the "Stone look"
- Concrete is subject to cracking, and if moisture is allowed to infiltrate into the wall, then due to freeze thaw conditions, the cracks could widen, which will result in frequent deterioration and repairs.
- Continue to monitor deterioration rates and adjust Useful Life as necessary in future updates.

Estimate for major repairs

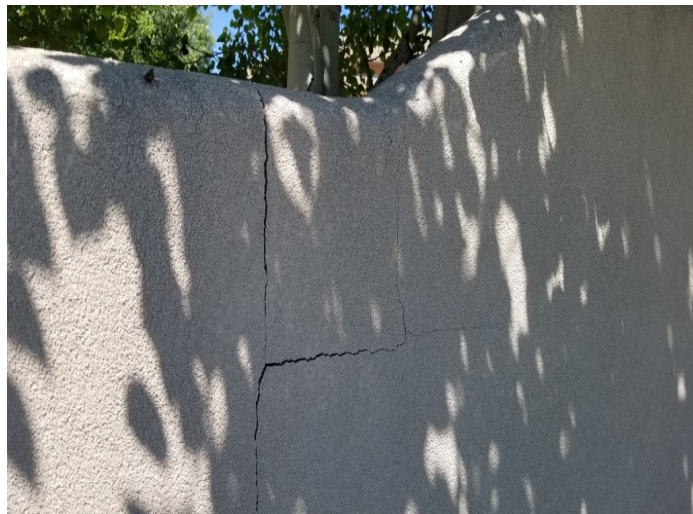
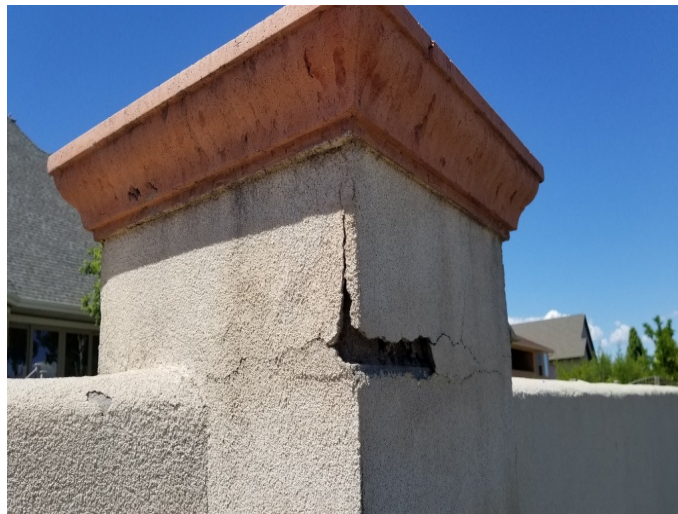
Comp #: 1012 Stucco Wall - Inspect/Repair

- Visible cracks, and stucco coating beginning to bubble and separate from the main subsurface.
- Based on age of community and observed conditions, we recommend establishing Reserve funding for periodic inspections and repairs every 5 - 7 years.

Estimate to inspect and repair

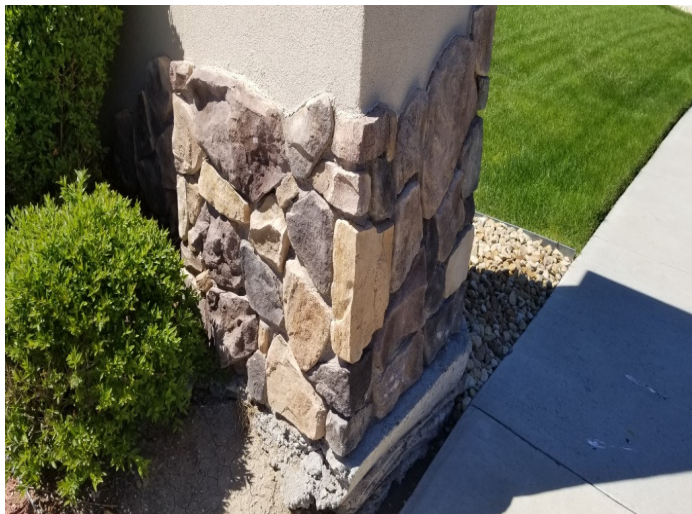
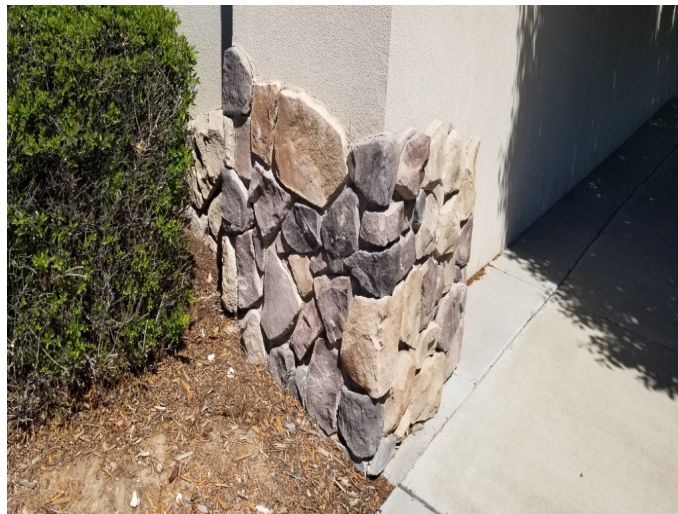
Comp #: 1013 Stonework - Major Repairs

- Individual area is too small for separate Reserve designation.
- Repair on an as needed basis with general operating funds.

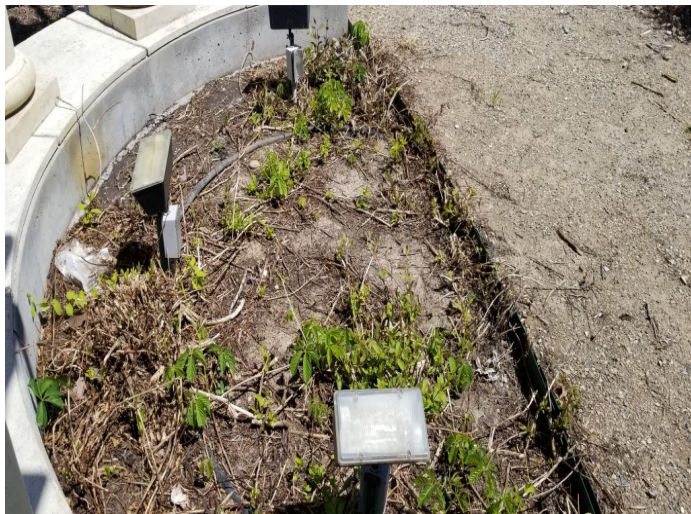
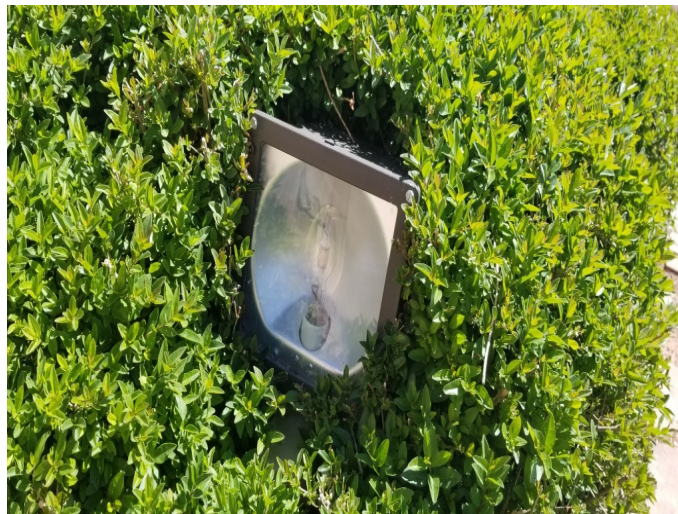
Comp #: 1603 Landscape Lights - Replace

- No reported problems with lights. Most associations are converting to LED lights for better efficiency and improved lighting.
- The average replacement cycle for landscape lights ranges from 15 - 20 years.

Best Cost: **\$2,475**
\$225/light; Estimate to replace

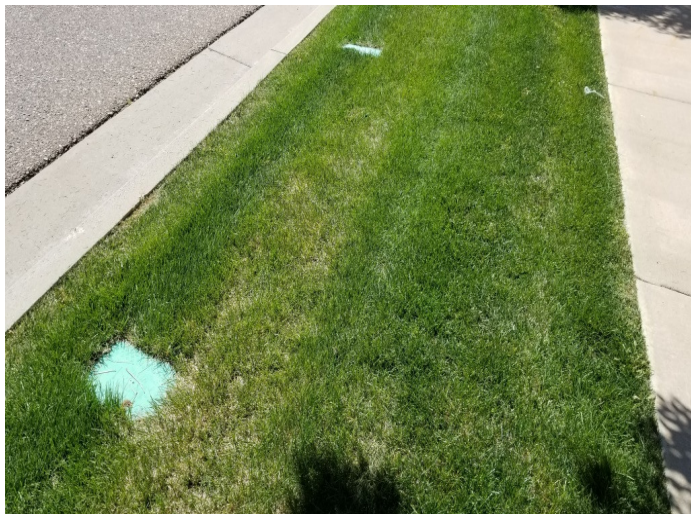
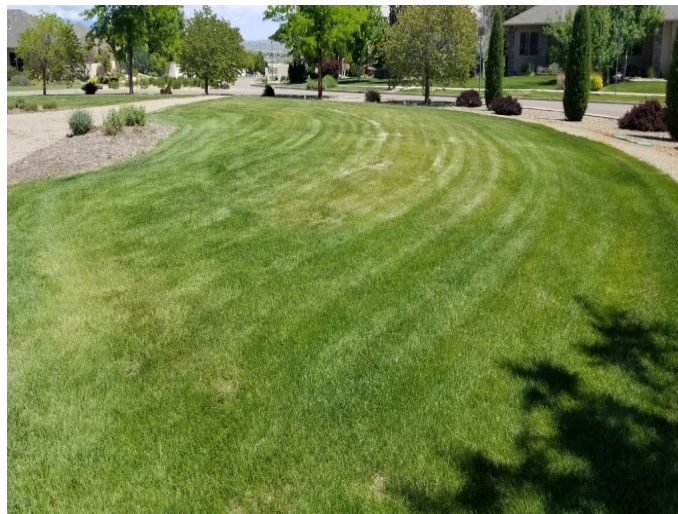
Comp #: 1701 Irrigation System - Major Repairs

- Drip line system at entrance monuments
- This line item is for repairs and replacement that lies outside the scope of routine maintenance: bulk sprinkler head replacement, bulk valve replacement, rerouting lateral lines, rewiring, etc.
- In order to ensure the funds are available for major repairs, we recommend reserving funds for these projects every 5 - 8 years.
- The funding on this line item is for major repairs and is not to be interpreted as complete irrigation system replacement.

Estimate for major repairs and renovating system

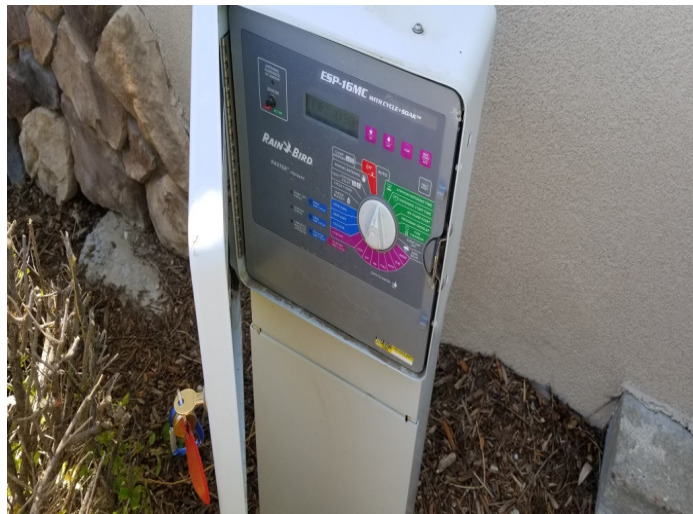
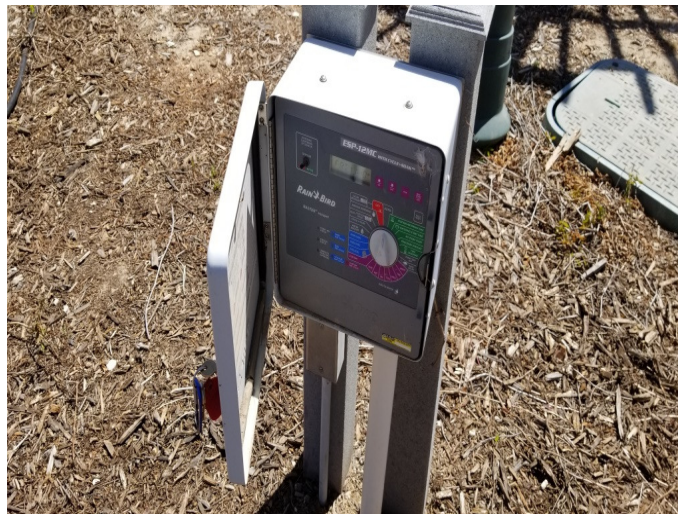
Comp #: 1703 Irrigation Controllers - Replace

- Expect to replace irrigation controllers every 15 - 18 years if properly maintained and under normal conditions.
- Funding is for replacement with a similar controller.
- Evapotranspiration (also known as ET) based controllers are also available, but cost significantly more. ET timers are more efficient and can be controlled remotely by landscaping experts, saving the association irrigation water costs.

\$1500/controller; Estimate to replace with similar

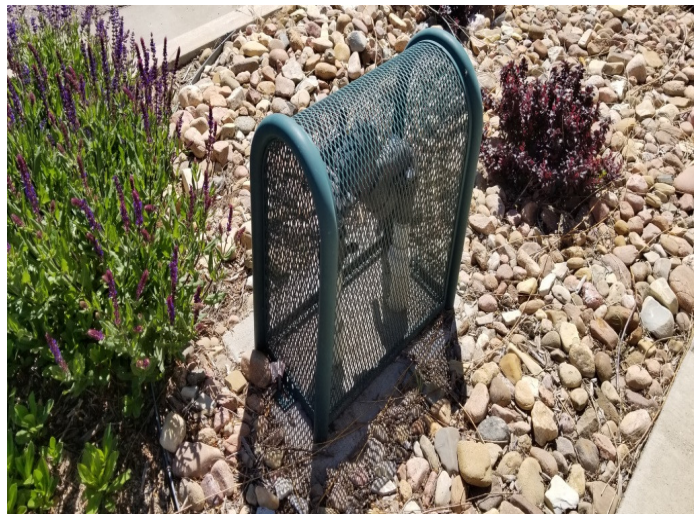
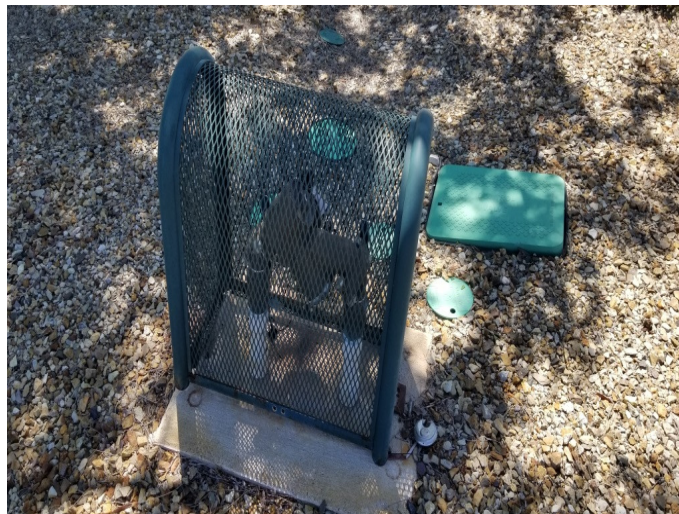
Comp #: 1706 Backflow Devices - Replace

- All devices are enclosed in a protective cage to prevent theft. No reported problems with any of the devices.
- Due to the ability to rebuild and replace these devices for a relatively low cost and the fact that failure of the device is unpredictable, we do not recommend reserving for replacement.
- Repair and/or replace these devices/cages on an as needed basis using operating funds.

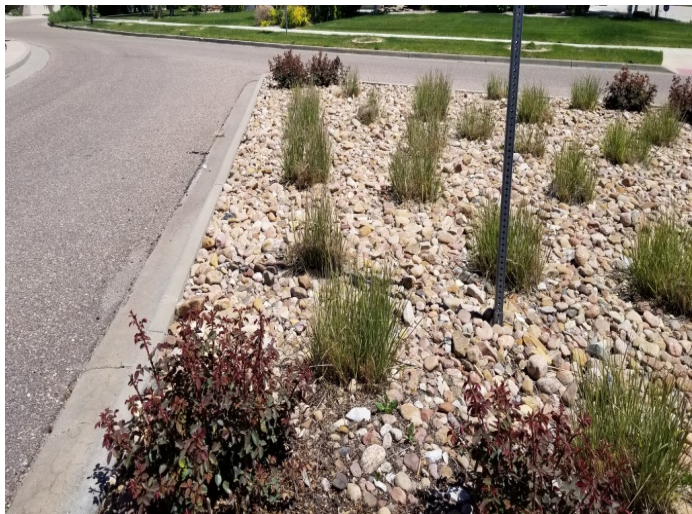
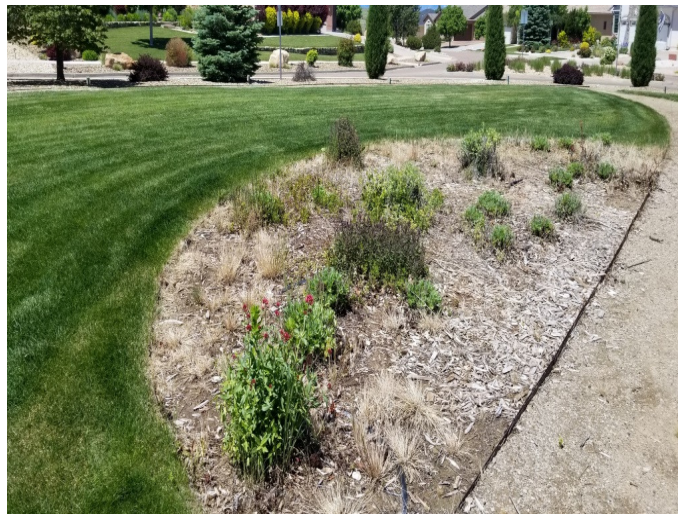
Comp #: 1801 Groundcover - Replenish

- This line item, similar to irrigation repairs, is for projects that lie outside the scope of routine maintenance.
- In order to preserve an attractive curb appeal and to maintain the health of the plants and shrubs, we recommend reserving for refurbishment projects every 2 - 4 years.
- This line item is for cyclical refurbishment and should not be considered as complete landscaping replacement.

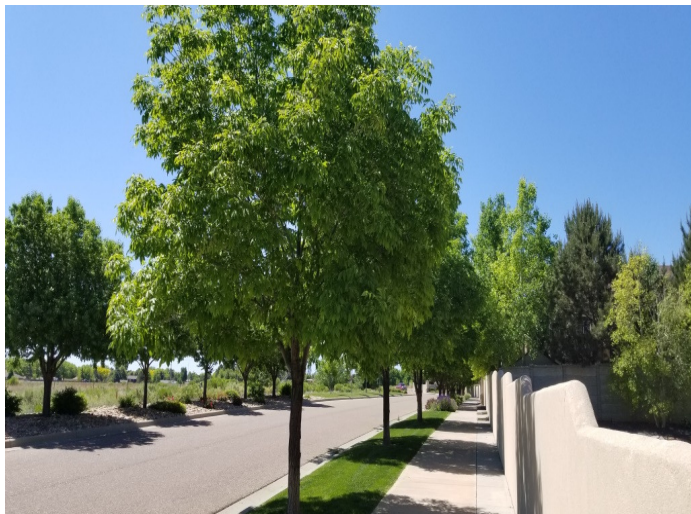
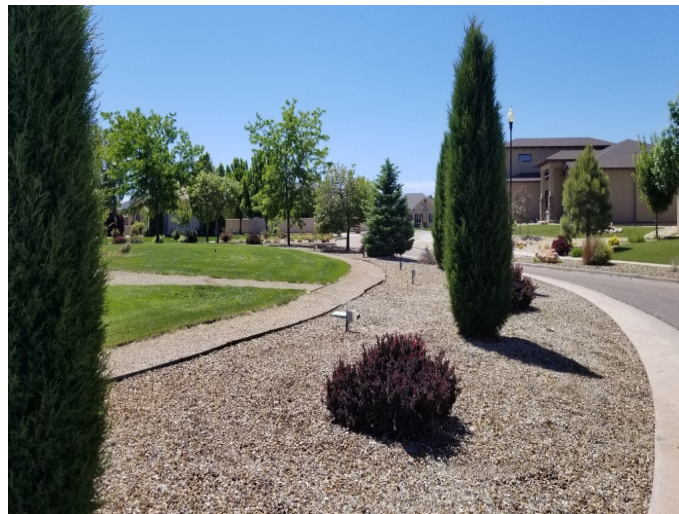
Comp #: 1804 Tree - Replacement/Major Maintenance

- It is very difficult to predict a replacement cycle for trees as there are several factors that will contribute to a tree dying.
- Factors such as disease, infestation of insects, heavy snow storms, etc. can all attribute to eventual tree replacement.
- Reserve an allowance for periodic replacement or major maintenance of trees every 6years

Estimate for partial replacement
